Case Study

Quality issues in hybrid microcircuits – A case study

Vikram Sarabhai Space Centre, Thiruvananthapuram, Kerala, India

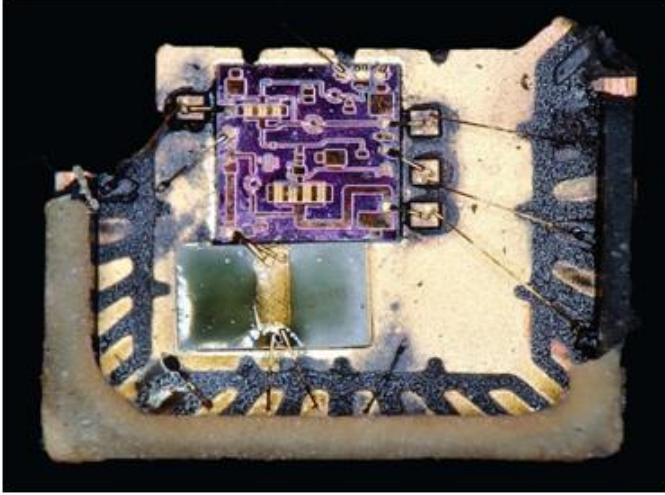
Further, the device failed in the leak test indicating poor hermeticity. The device was de-lidded and optically inspected under magnification for internal visual examination. Contamination and burnout were observed inside the device packaging as given below [2] (Figure 1).

Figure 1: Failed device.

It was evident from the above figures that there was contamination for the failed device which had resulted in the failure. Also, the hermeticity of the device was poor as it failed in both fine leak and gross leak tests as per MIL STD 883 [1].

1. Improvements can be made in the fabrication process by adopting better device packaging procedures as those used for military class devices.
2. Ceramic casing with laser welding shall be adopted to ensure hermeticity.
3. A Nitrogen (inert) atmospheric pre-seal bake followed by Nitrogen atmosphere lid seal will avoid moisture entrapment in device packaging.[8]
4. Biased HAST (BHAST) can be part of the qualification for evaluating the reliability of non-hermetic packaged devices in humid environments. When devices are subjected to HAST, moisture penetrates the packaging and when voltage bias is applied, metal from the anode is ionized and

5. 100 % Pre-Cap inspection on all devices fabricated to bring out deviations in the material used, fabrication, and construction [1].

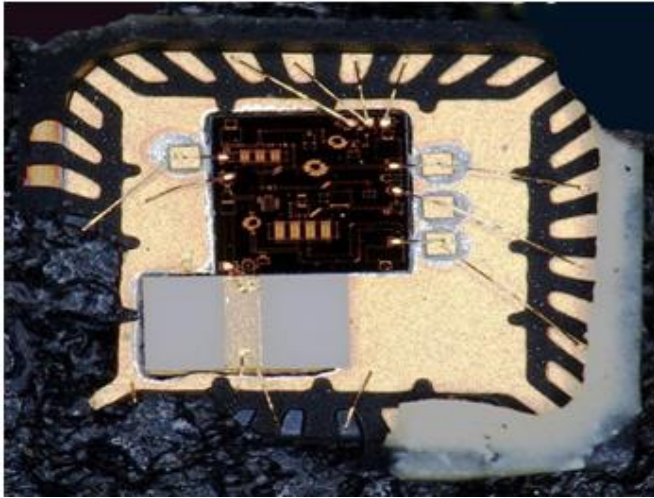
A fresh good device was de-lidded for reference and optically inspected under magnification. No such signature was observed as seen in the failed device (Figure 2).

Figure 2: Reference device.

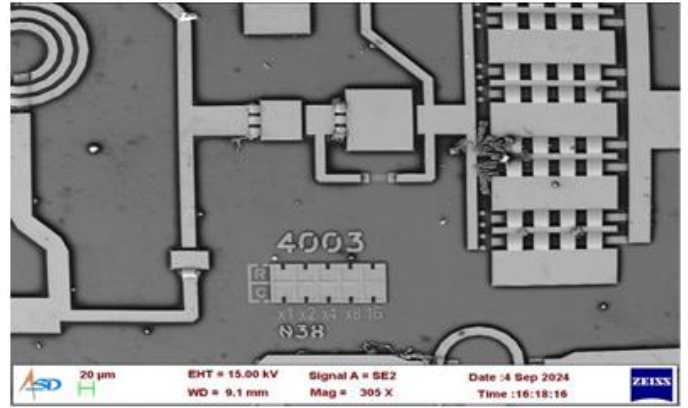
Morphological analysis of the failed device revealed the presence of dendrites-like growth between the circuit components and EDS analysis confirmed the presence of copper in these dendrites-like structures (Figure 3). In addition to that carbon was observed throughout the interfaces of the

circuit components in the failed device. However, the reference device was lacking any of such features (Figure 4).

Figure 3: SEM image of Failed device.

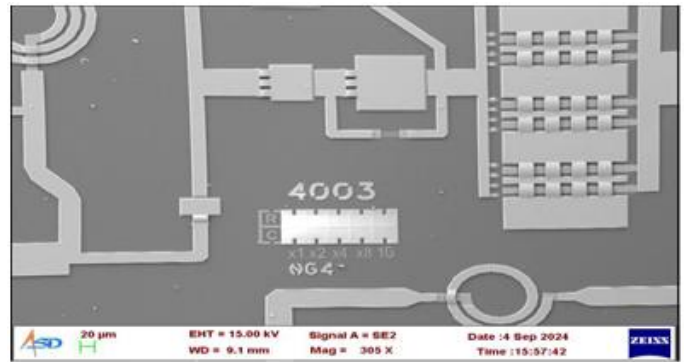
Figure 4: SEM image of Reference device.

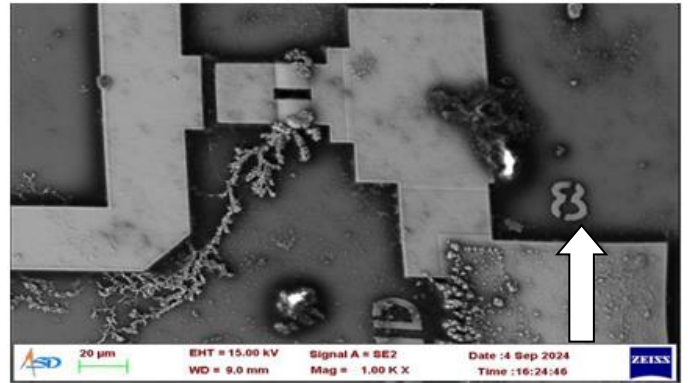
SEM images indicate undesired dendrite growth and carbon deposits between the circuit components [3] (Figure 5).

Figure 5: Dendrites and carbon deposits.

During the formation of dendrite, the surface resistance between the anode and the cathode decreases. Eventually, the dendrite will electrically connect the two electrodes i.e., metal tracks and short them. Here the metal that migrated between tracks is Copper, whose source is identified in the lead frame which is part of device packaging.

All the above analyses indicate that the device was contaminated, which caused ECM resulting in Cu dendrite growth between metal tracks with the application of electrical power. The low resistance path between the tracks resulted in device short mode failure, burning, and carbon deposition.

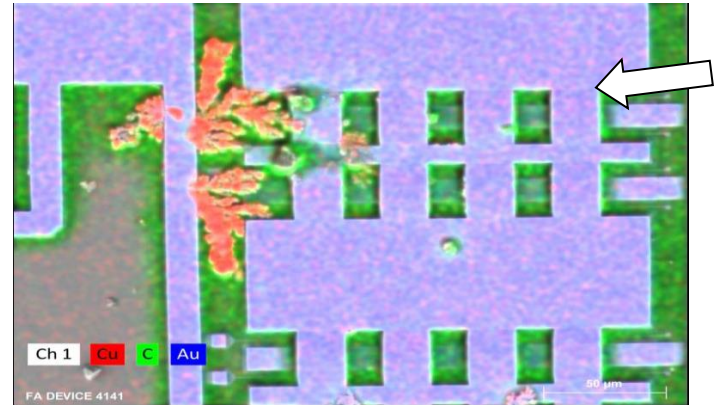
Elemental mapping also shows copper and carbon distribution between inter digitated circuits (Figure 7).

Figure 7: Elemental Analysis indicating Cu growth between metal tracks.

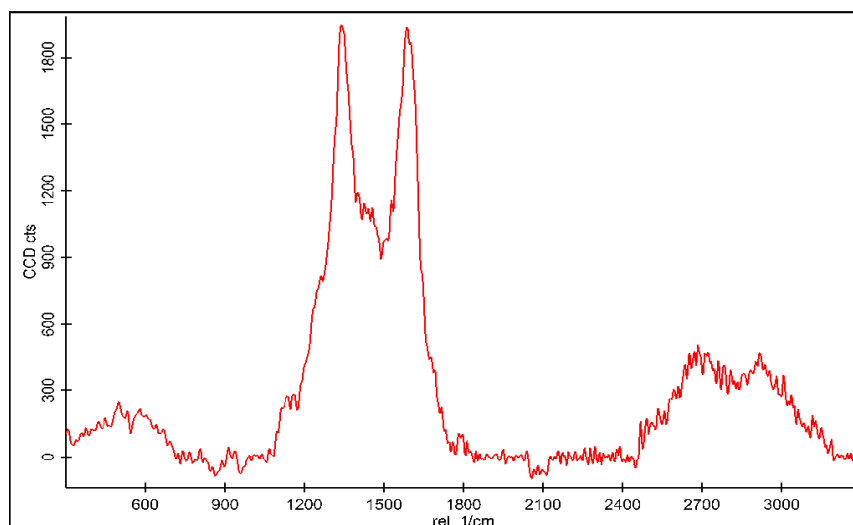
Carbon species observed on the failed device were further analyzed by Raman spectroscopy and characteristic spectral features of ordered carbon (due to high-temperature burning) were obtained (Figure 8).

Figure 8: Raman spectrum from the failed device showing characteristic carbon peaks.
