Cite this article: B. Kaur, K.K. Waraich, O.P. Pandey, Microstructural and thermo-physical evaluation of spontaneous fracture in automotive rear windshields: The role of carbonaceous impurity segregation, *RP Materials: Proceedings* Vol. 5, Part 1 (2026) pp. 214–223.

Microstructural and thermo-physical evaluation of spontaneous fracture in automotive rear windshields: The role of carbonaceous impurity segregation

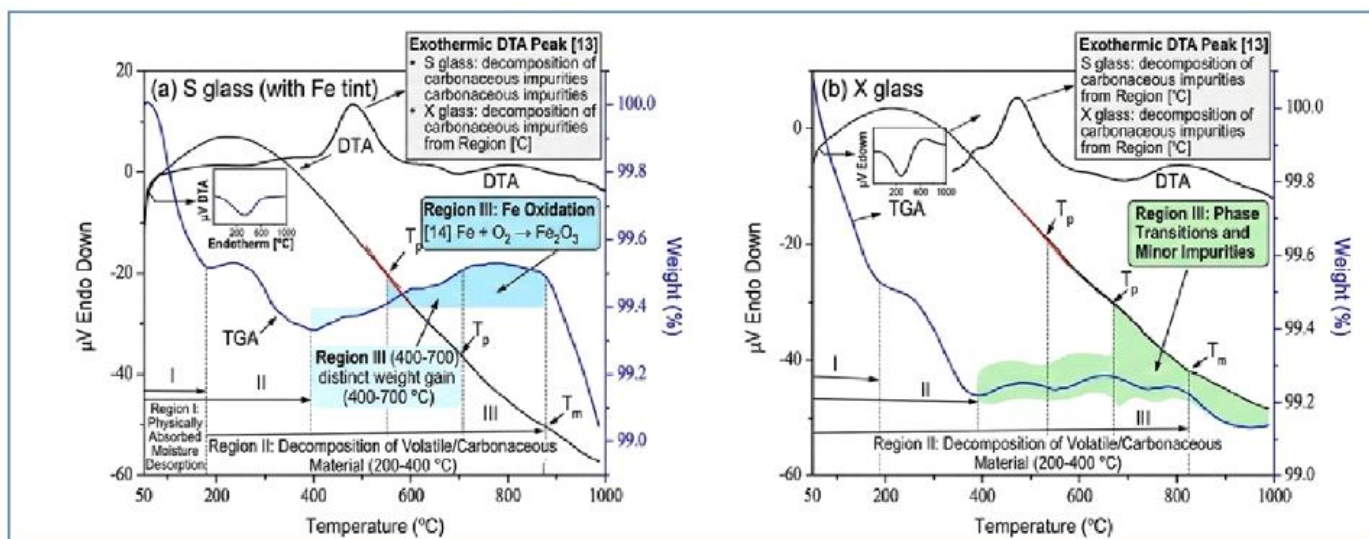
Figure 1: DTA and TGA analysis of (a) S glass and (b) X glass.

For both glasses, the TGA curves show an initial weight loss up to approximately 200 °C (Region I), which is primarily attributed to the desorption of physically absorbed moisture. A more significant weight loss is observed between 200 °C and 400 °C (Region II) [13]. This weight loss is indicative of the presence of volatile components or the decomposition of bonded elements, possibly carbonaceous material, within the closed pores or as impurities within the glass structure. In the case of S glass (Figure 1(a)), a distinct weight gain is observed between 400 °C and 700 °C (Region III), which can be attributed to the oxidation of the iron (Fe) constituent, consistent with its known presence as a tinting agent [14]. Concurrently, the DTA curves reveal an exothermic peak around 450 °C for both S and X glasses, which strongly correlates with the burning off and oxidation of these carbonaceous impurities, providing further evidence of their presence within the glass matrix.

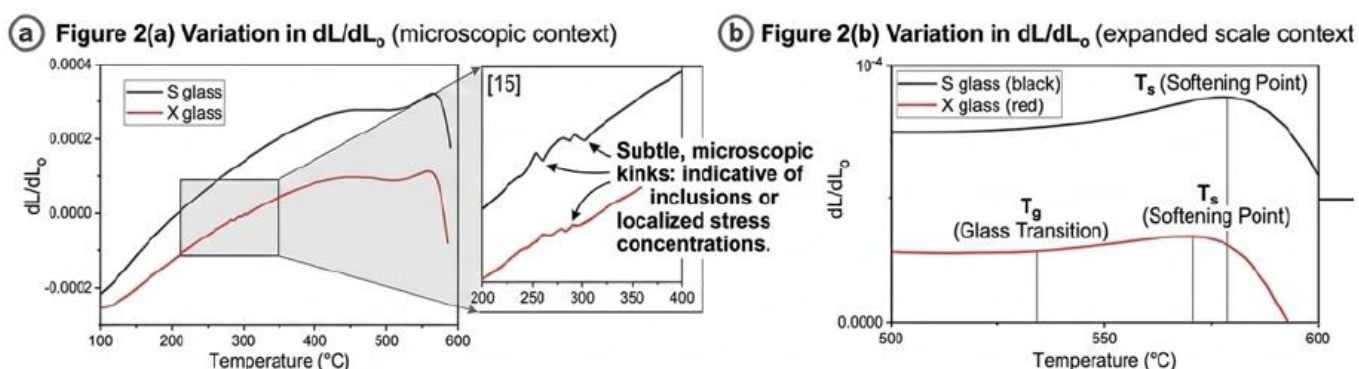
Figure 2: Variation in TEC values of (a) S glass and (b) X glass.

Figure 2 illustrates the thermal expansion behavior, specifically the variation in length relative to the original length (dL/dL_0), for both glass samples. Both S and X glasses generally exhibit a linear thermal expansion behavior with increasing temperature, as expected for amorphous materials, typically showing a coefficient of thermal expansion on the order of 10^{-6} K^{-1} . However, a careful and magnified analysis of the dilatometer curves in Figure 2(a) reveals subtle, microscopic kinks occurring between 200 °C and 400 °C [15]. While not confirmatory on its own, this behavior is highly symptomatic of localized internal stresses or microstructural changes. It suggests the possible presence of elements or

inclusions within the glass matrix that possess a different coefficient of thermal expansion compared to the bulk glass. Upon heating, this thermal expansion mismatch can lead to localized detachment from the base matrix, potentially causing the formation of voids or localized stress concentrations within the glass. This initial observation provides a crucial symptomatic link to the presence of impurities that could influence the overall thermal stability and mechanical integrity of the windshield. The key thermal properties derived from these measurements, as observed in Figure 2(b), are comprehensively summarized in Table 2.

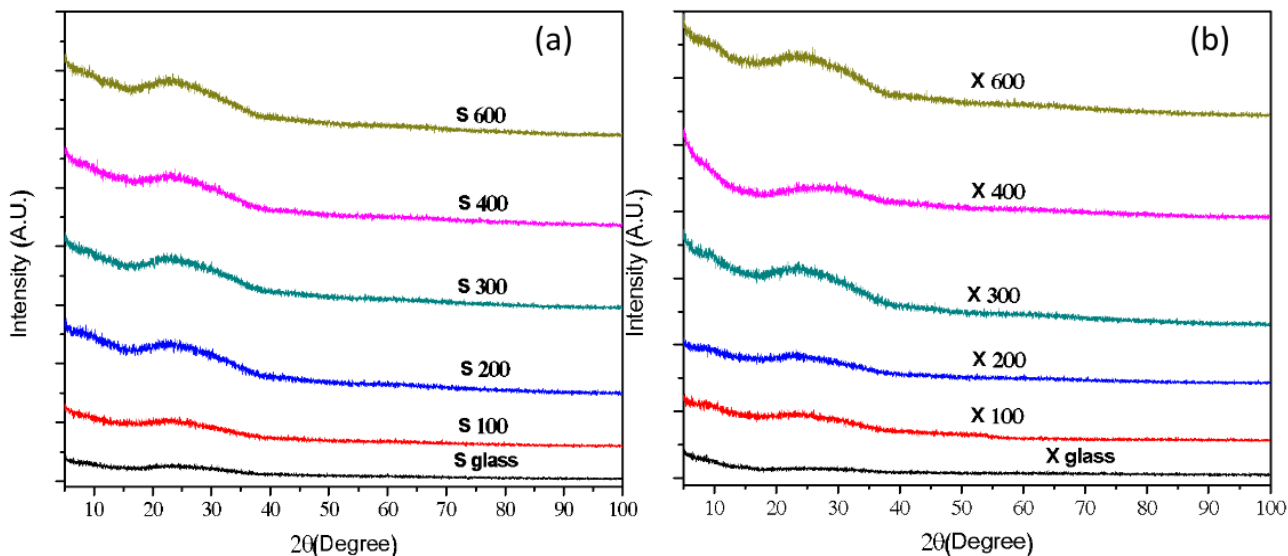
Figure 3: XRD pattern of as-received glasses and heat-treated windshield glasses showing amorphous characters.

Crucially, the XRD diffractograms of all heat-treated S and X glass samples, even those exposed to temperatures as high as 600 °C, consistently revealed the complete absence of any crystallized phases. The characteristic broad hump, a definitive indicator of an amorphous structure, remained prominently present in all analyzed samples. This robust analysis unequivocally demonstrates that the glass does not transform into a glass-ceramic or any other crystalline phase, even when subjected to significantly elevated temperatures within the operational range. Furthermore, it is important to note that this XRD analysis is sensitive enough to detect crystalline phases with a basic percentage exceeding 5%, thereby conclusively excluding the possibility of glass crystallization leading to the observed fractures in the windshields [16].

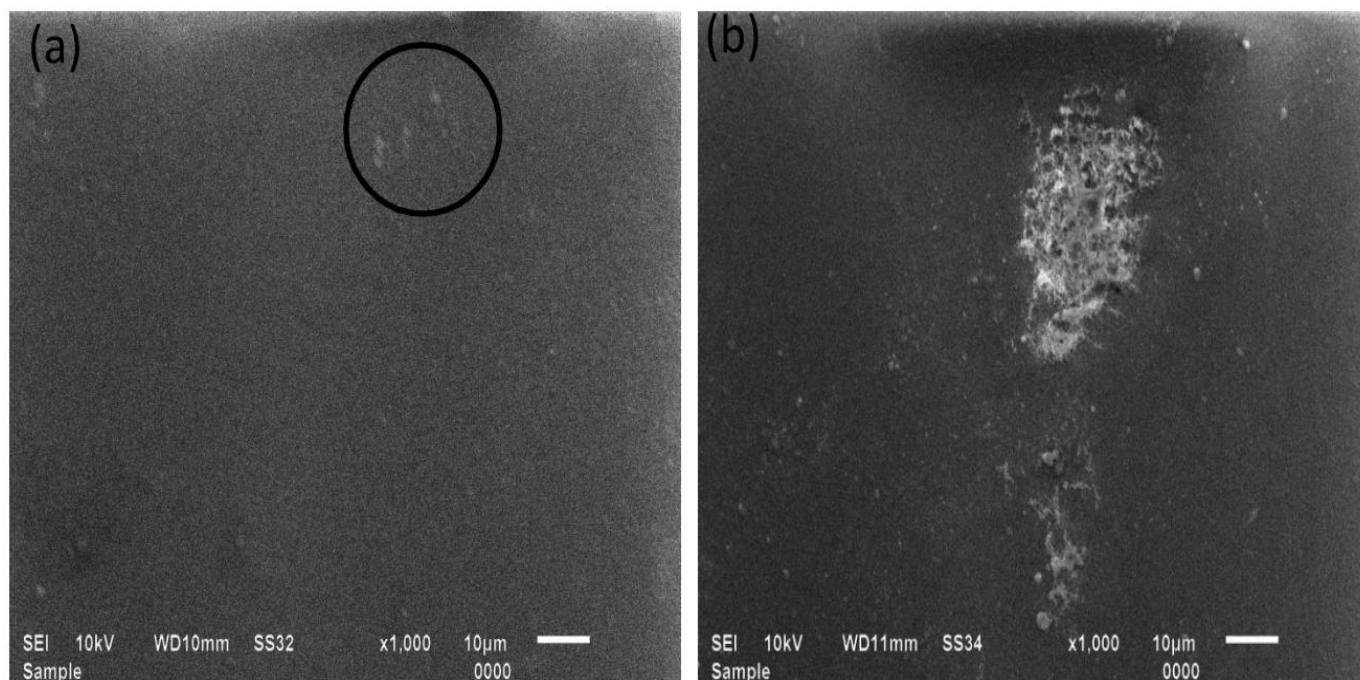
Figure 4: Scanning electron micrograph of the surface of S glass as received.

SEM analysis of the 'S' glass revealed significant heterogeneities across its surface, as depicted in Figure 4. Figure 4(a) highlights discrete inclusions observed in specific, localized areas, indicating non-uniformity in the glass matrix. Furthermore, Figure 4(b) shows that these inclusions were not isolated but often appeared in clusters within different regions, suggesting a pattern of impurity distribution rather than random occurrences. The visual characteristics of these light-colored inclusions strongly suggested the presence of carbonaceous material.

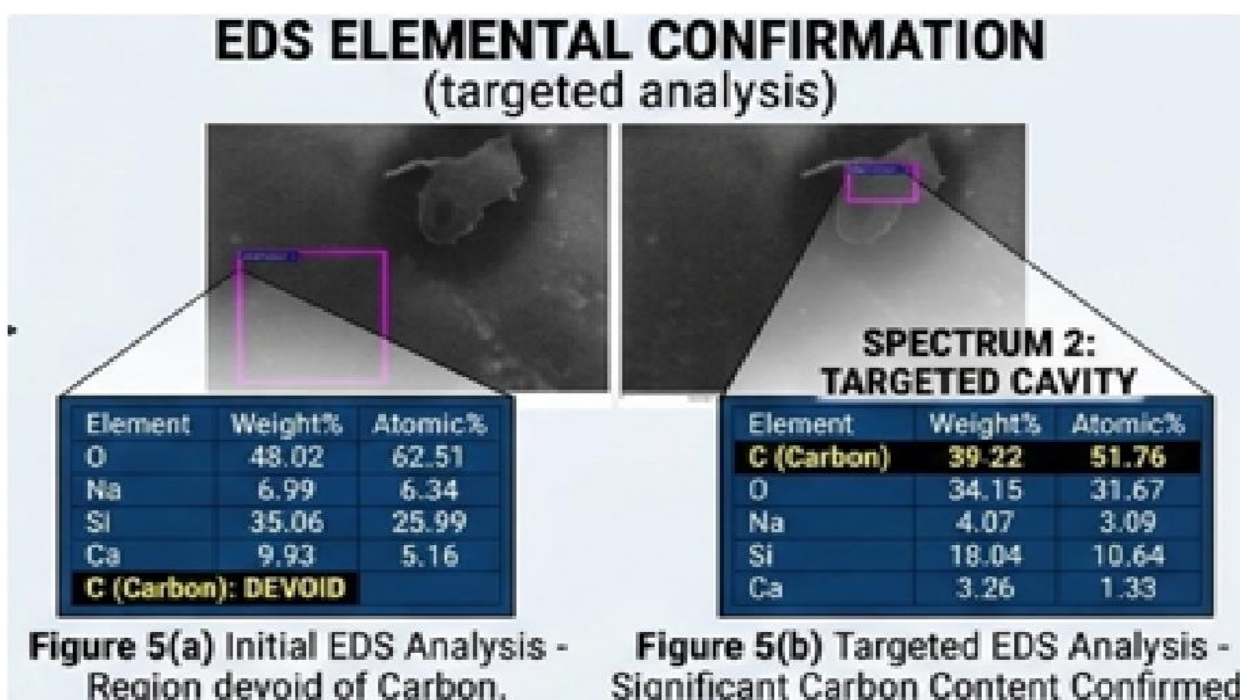
Figure 5: Back scattered electron micrograph with EDS analysis from the cleaned surface of S glass.

To definitively confirm the elemental composition of these inclusions, Energy-Dispersive X-ray Spectroscopy (EDS) analysis was performed by selecting specific areas on the glass surface. Figure 5 illustrates these selected areas for EDS investigation. Initially, a small area within a defined box was analyzed, as shown in Figure 5(a). The corresponding EDS spectra and elemental analysis (to be presented in a formalized Table 5 (a) indicated that this particular analyzed region was surprisingly devoid of carbon content, suggesting the heterogeneous nature of the inclusions.

However, a distinct zone, visually characterized by a prominent dark cavity, was subsequently analyzed as illustrated in Figure 5(b). This second, targeted EDS analysis unequivocally confirmed the presence of significant carbon

content within the observed inclusions, as detailed in the corresponding elemental analysis (to be presented in a formalized Table 5(b). The observation of a dark cavity surrounding these carbon-rich areas is particularly significant. This morphology suggests that these carbon particles have preferentially occupied regions where solute rejection is at its maximum during the glass solidification process, typically occurring at the solid-liquid interface [17]. This phenomenon, often associated with solidification shrinkage, leads to the segregation of impurities like carbon into these localized areas, creating zones of compositional and structural inhomogeneity within the glass. These carbon-rich regions become critical points of weakness that can initiate fractures under thermal stress.

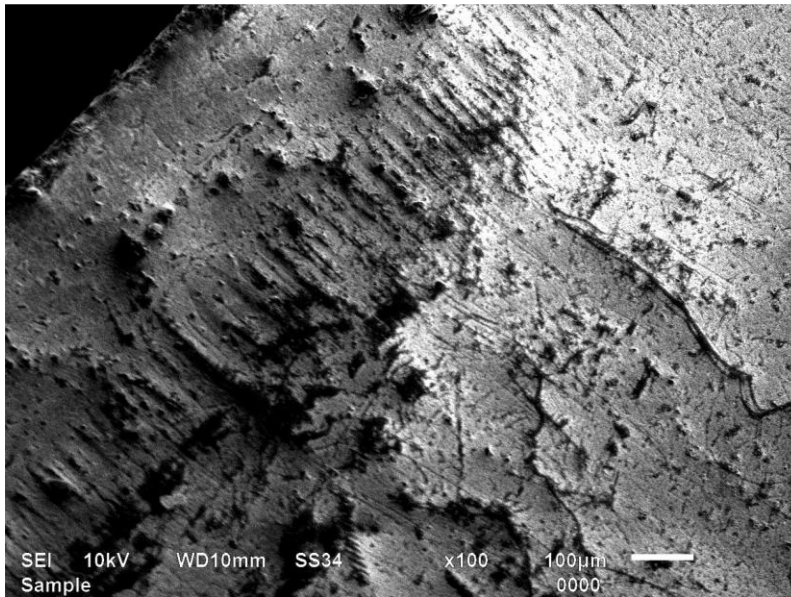
Figure 6: Scanning electron micrograph of the fractured area of S glass as received.

Figure 6 provides a compelling display of the topography within the fractured area of the S glass granules, offering critical insights into the underlying failure mechanism. The observed morphology distinctly indicates the pervasive presence of solidification shrinkage, a phenomenon inherent to the cooling and solidification of molten glass. This is unequivocally evidenced by the distinct, parallel shrinkage marks visible across the fractured surface. These marks are characteristic features formed when the molten glass contracts upon cooling, leading to the creation of internal cavities or voids within the solidifying matrix.

Crucially, within these intricate cavities and regions defined by solidification shrinkage, a significant segregation of carbon impurities was observed. This suggests that carbon, likely originating from raw material inconsistencies, preferentially accumulates in these areas of volume deficit during the glass manufacturing process. These structural anomalies, characterized by the presence of segregated carbon, typically begin to manifest at a depth of approximately 300 μm below the original glass surface. This depth indicates that these weaknesses are not merely superficial but extend into the bulk of the material, making the glass inherently vulnerable.

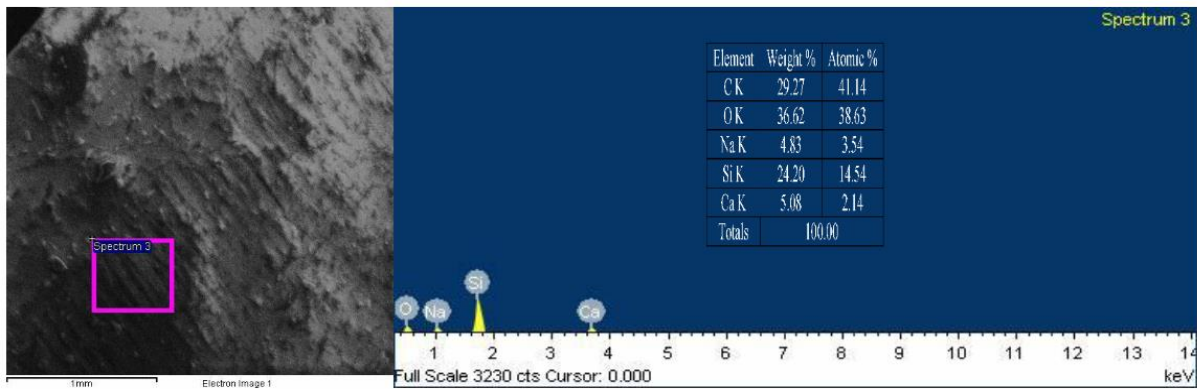
Figure 7: Back-scattered electron micrograph with EDS analysis from the fractured area of S glass.

To provide definitive elemental confirmation of these impurity-rich zones, a targeted Energy-Dispersive X-ray Spectroscopy (EDS) analysis was conducted on specific areas within the fractured region, as visually illustrated by the box in Figure 7. The detailed elemental analysis from these highlighted regions, which should be comprehensively presented in an accompanying table, consistently revealed a significantly higher carbon content compared to the surrounding homogeneous glass matrix. This direct confirmation of carbon enrichment within the solidification shrinkage marks underscores these areas as critical points of compositional and structural inhomogeneity. The presence of these carbon-rich inclusions, with their distinct morphology and segregated nature, acts as a primary stress concentrator. Their inherently different coefficient of thermal expansion compared to the surrounding silicate glass leads to severe localized thermal stresses, particularly when the windshield undergoes rapid temperature fluctuations (e.g., from cooling in shade to direct exposure to hot sun), ultimately initiating and propagating cracks that result in the observed spontaneous shattering.

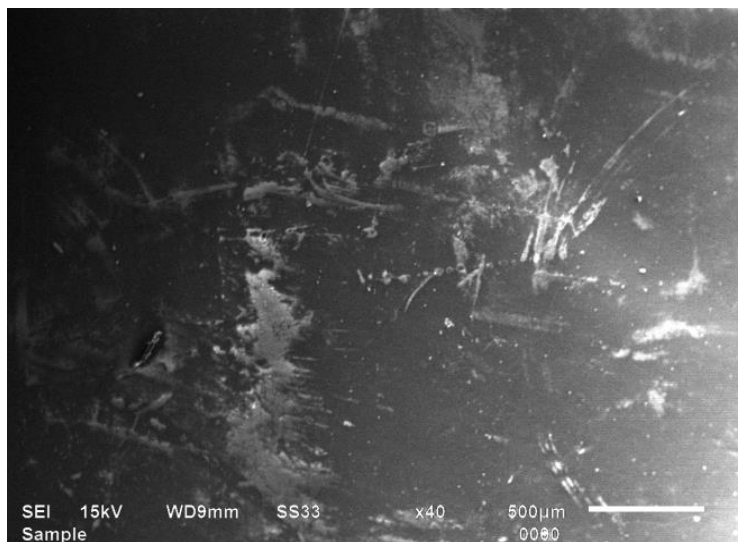
Figure 8: Scanning electron micrograph of the surface of X glass as received.

Figure 8 presents a crucial SEM image of the X glass surface, revealing distinct microstructural features contributing to its failure. At various locations, the surface exhibits pronounced flow lines, indicative of inherent non-uniformities within the glass matrix, likely stemming from laminar flow patterns during the float manufacturing process. Concurrently, inclusions are consistently observed along these flow lines,

distributed throughout the entire cross-section of the structure. This widespread presence creates a significantly heterogeneous microstructure, where undesirable heterogeneities are segregated, fundamentally compromising the uniformity and integrity glass.

Figure 8 presents a crucial SEM image of the X glass surface, revealing distinct microstructural features contributing to its failure. At various locations, the surface exhibits pronounced flow lines, indicative of inherent non-uniformities within the glass matrix, likely stemming from laminar flow patterns during the float manufacturing process. Concurrently, inclusions are consistently observed along these flow lines, distributed throughout the entire cross-section of the structure. This widespread presence creates a significantly heterogeneous microstructure, where undesirable heterogeneities are segregated, fundamentally compromising the glass's uniformity and integrity.

The systematic distribution of these carbon inclusions, particularly along flow lines and within areas of increased heterogeneity, strongly suggests a manufacturing-related origin. It appears highly probable that these glass fragments, rich in carbon inclusions, originate from the end portions of the last castings during the production process. These sections

are typically more prone to such inhomogeneities and impurity segregation due to cooling dynamics and material flow patterns at the very end of the casting run. The pervasive presence and localized concentration of these carbon impurities, combined with their different thermal expansion coefficients compared to the surrounding glass, create inherent stress points that significantly reduce the overall strength and thermal shock resistance of the windshield, leading to its spontaneous shattering under thermal cycling.

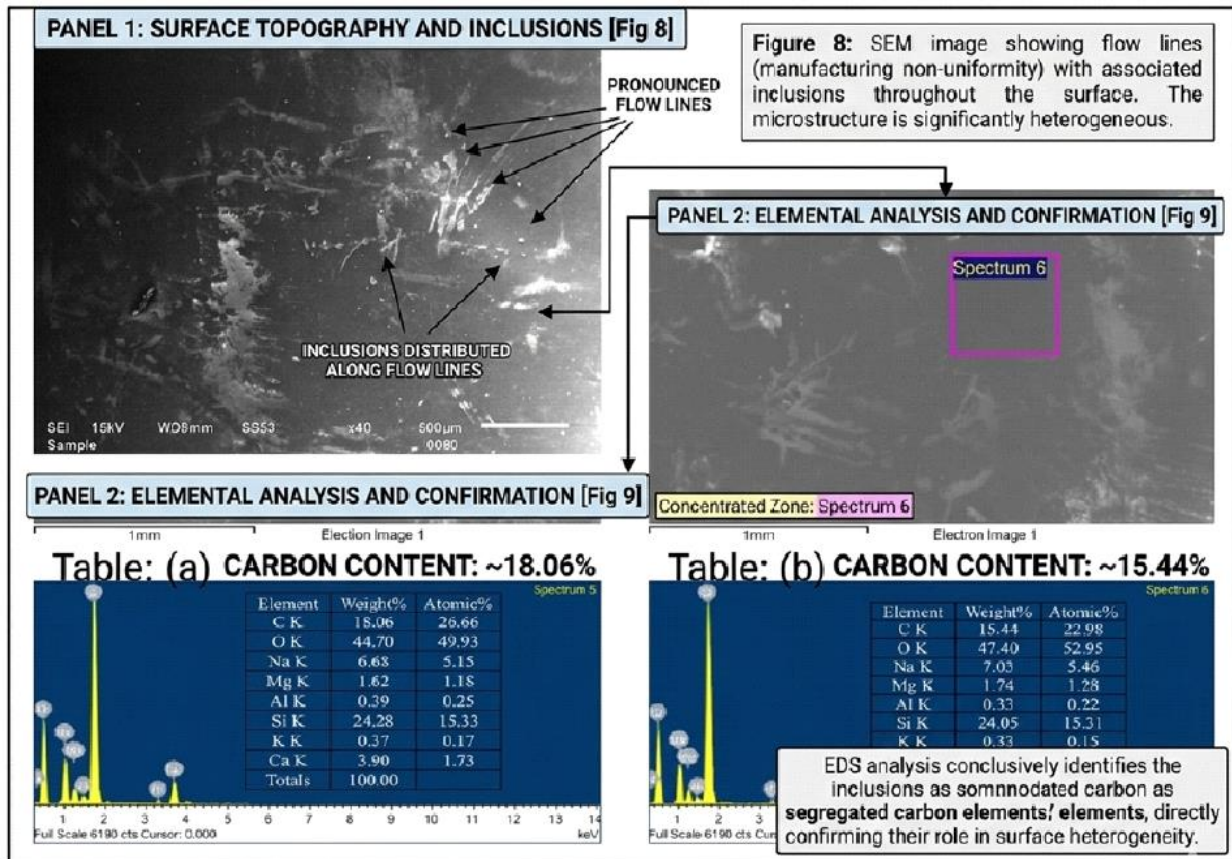
Figure 9: Back-scattered electron micrograph with EDS analysis from the surface of X glass.

****Comprehensive analysis of X-glass surface heterogeneity:** Figure 8 shows microstructural flow lines and associated inclusions, while Figure 9 provides EDS elemental confirmation of carbon as the heterogeneous element.

To conclusively identify the elemental composition of these heterogeneities, a focused Energy-Dispersive X-ray Spectroscopy (EDS) analysis was performed, as depicted in Figure 9. When the area under analysis was expanded to encompass regions containing both the bulk glass and these inclusions, the obtained carbon content measured approximately 18.0%, illustrated in Figure 9(a). Furthermore, a separate, more concentrated zone within the same area, illustrated in Figure 9(b), revealed an even higher carbon content, reaching up to 15.44%. These specific inclusions are unequivocally identified as carbon elements, confirming their direct role in the observed heterogeneity.

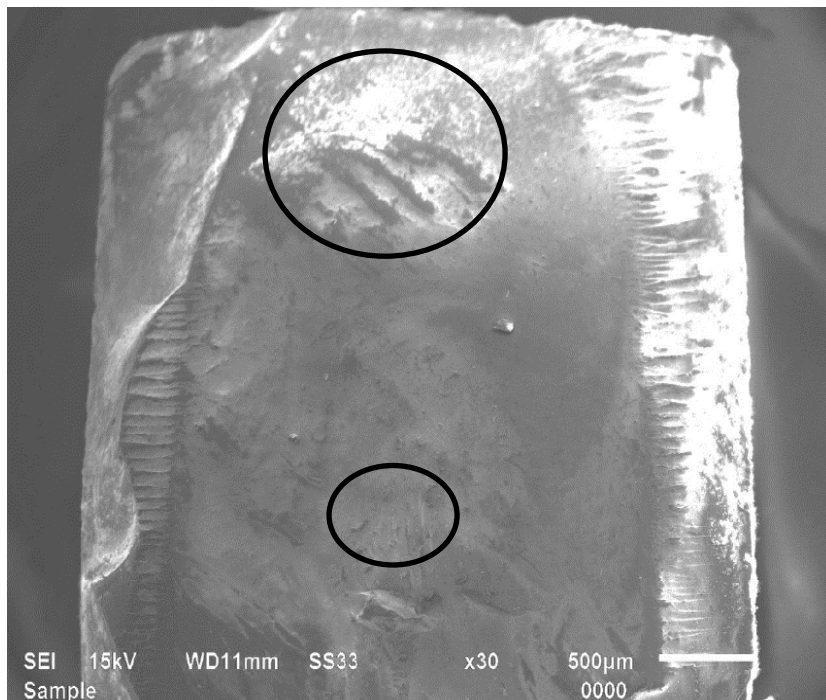
Figure 10: Scanning electron micrograph of the fractured area of X glass as received.

Figure 10 provides a comprehensive representation of the entire cross-sectional area of the fractured surface of the X glass, offering critical insights into the internal distribution of impurities and the solidification process. In this micrograph, both ends of the cross-section distinctly exhibit a columnar drain structure, which manifests as prominent parallel lines extending inwards. Additionally, at the top and bottom regions of the cross-section, large clusters of inclusions are visibly segregated and prominently encircled, indicating significant areas of concentrated impurities.

This observation is highly consistent with the dynamics of glass solidification. During the cooling process, heat flows predominantly from the centre towards the surface of the solidifying glass. This directional heat release drives the fluid molten glass to move along these paths, effectively acting as conduits. Impurities, being less soluble or having different densities, tend to follow this path of fluid flow. As solidification progresses, these impurities become increasingly concentrated and ultimately get trapped within these columnar drain lines, forming the observed parallel structures.

Furthermore, in the central part of the cross-section, where solidification typically occurs last, solidification shrinkage is most pronounced. In these areas, the contracting glass creates larger voids and spaces, providing ample room for substantial

"chunks" of impurities to segregate, which are encircled in Figure 10. These represent macroscopic accumulations of defects that profoundly compromise the glass's integrity.

Furthermore, the specific morphology of carbon segregation, particularly within the drain-like structures and larger segregated chunks (as observed in Figure 10), acts as a highly effective stress concentrator. These pre-existing defects, combined with the thermally induced stresses, render the glass inherently vulnerable. Even in the absence of a direct impact, the accumulated internal stresses can reach the fracture strength of the glass. This precarious state makes the windshield highly susceptible to shattering upon even slight external perturbations, such as minor mechanical shocks or vibrations experienced during normal vehicle movement, which would typically be harmless to an intact windshield. This vulnerability is strongly supported by comprehensive structural analysis and is consistent with the reported failure incidents [19]. Thus, the presence and specific distribution of carbon impurities directly compromise the thermal and mechanical integrity of the automotive glass.

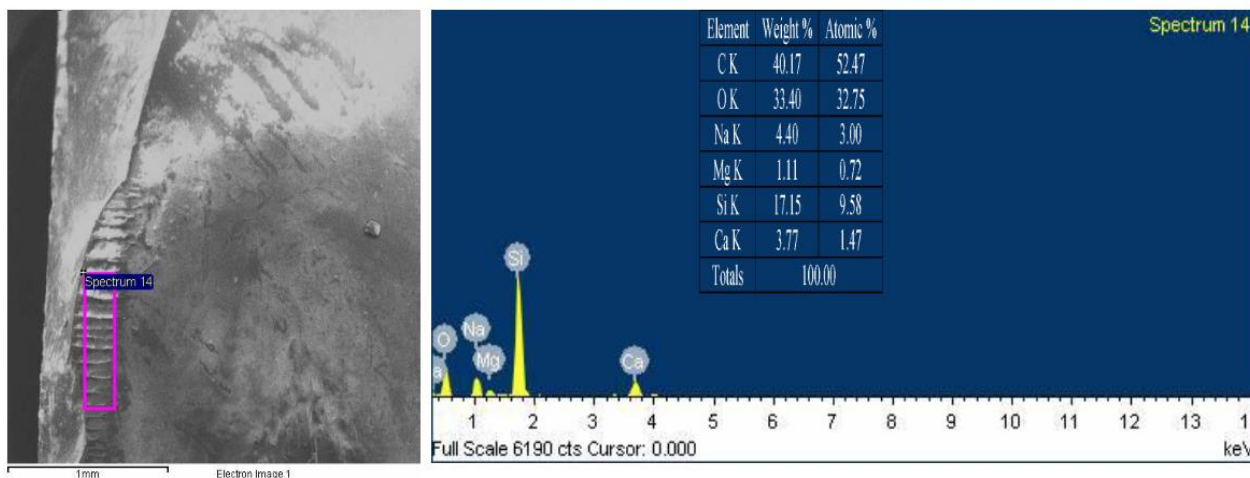
Figure 11: Back-scattered electron micrograph with EDS analysis from the fractured area of X glass.

To confirm the elemental composition and concentration of these highly segregated impurities, a targeted Energy-Dispersive X-ray Spectroscopy (EDS) analysis was performed at one end of the cross-section, specifically focusing on a region where impurities were visibly aligned within the columnar drains. The precise area where this analysis was conducted is displayed in Figure 11. The results of this EDS analysis illustrate an exceptionally comprehensive view of carbon segregation, with its percentage amounting to a remarkably high 40.17%. This extremely elevated

concentration of carbon, particularly within the columnar drain structures and large segregated clusters, definitively confirms that these impurities are carbonaceous. Their widespread distribution, high concentration, and entrapment within solidification features create significant internal inhomogeneities and localized stress concentrations, serving as the primary origin points for the thermal expansion mismatch that ultimately leads to the catastrophic shattering of the windshields.
