Case Study

Quality issues in hybrid microcircuits – A case study

Vikram Sarabhai Space Centre, Thiruvananthapuram, Kerala, India

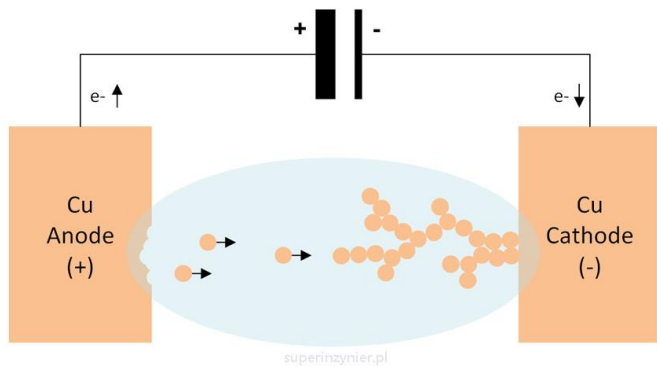
Figure 6: ECM process.

Dendrite growth is the result of electrochemical migration (ECM) processes. ECM occurs when moisture adheres between electrodes made of materials such as copper, solder or silver. When the bias voltage is applied, metal from the anode gets ionized and moves towards the cathode. Metal ions are formed by ionic dissolution of the anode [4].

forming dendrites or dendrite-like filaments (Figure 6).

Major factors causing dendrite growth are:

- Metals used in fabrication;
- Contaminants like flux residues;
- Electric field parameters like potential difference and electrodes spacing;
- Environmental factors like humidity.

ECM occurs with the application of electrical potential between metal tracks in the presence of metal ions. Sources of ions are flux residues, salt, non-distilled water or sweat from fingerprints [4]. These contaminants can enter into the device during Printed circuit board wiring process, where the device is subjected to chemical exposure as part of cleaning and reflow soldering. Unqualified sealing process can cause presence of moisture inside the device packaging leading to metal ion formation.

All the above analyses indicate that the device was contaminated, which caused ECM resulting in Cu dendrite growth between metal tracks with the application of electrical power. The low resistance path between the tracks resulted in device short mode failure, burning, and carbon deposition.

1. Improvements can be made in the fabrication process by adopting better device packaging procedures as those used for military class devices.
2. Ceramic casing with laser welding shall be adopted to ensure hermeticity.
3. A Nitrogen (inert) atmospheric pre-seal bake followed by Nitrogen atmosphere lid seal will avoid moisture entrapment in device packaging.[8]
4. Biased HAST (BHAST) can be part of the qualification for evaluating the reliability of non-hermetic packaged devices in humid environments. When devices are subjected to HAST, moisture penetrates the packaging and when voltage bias is applied, metal from the anode is ionized and
